SUMMARY OF

Utility Structures Assessment
Winnebago County Fairgrounds and Parkside
Per KonText Architects review November 16, 2012

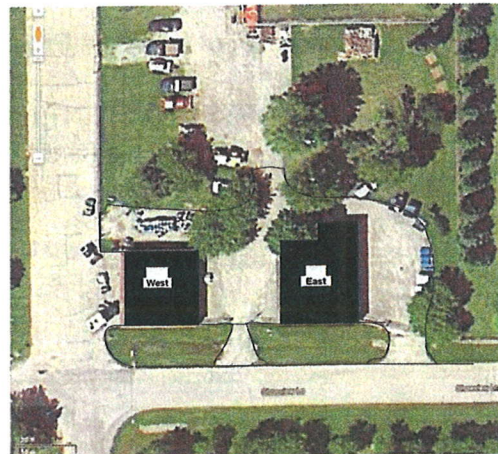
Fairgrounds Site: The illustration to the right is an overview of the existing site. The site offers outdoor storage of various items including vehicles and equipment. The topography of the site slopes upward to the north (top of illustration). The paving systems are fair to poor condition.

Of specific note, the existing storm water management is inadequate to protect the existing buildings from storm water run-off. This condition has been a direct contributor to the foundational physical condition of the two structures. *See individual building assessments for further discussion.*

Fairgrounds Site Recommendations: *At a minimum in order to address storm water influence on the two structures, a pavement replacement project is needed. This project should prioritize redevelopment of existing topography and installation of storm water piping systems. Collateral work may include but may not be limited to: removal of trees, fence replacement, and landscape restoration.*

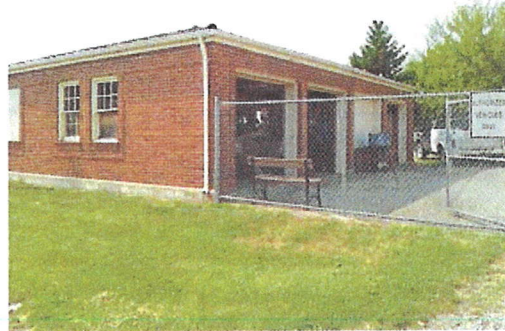
Fairgrounds West: This 1650sf structure is in fair condition with various building systems and/or assemblies in various degrees of disrepair and deterioration.

As suggested above, the storm water management on the site has been a contributing factor to some of the deterioration. This influence is exasperated by a lack of roof drainage at grade and the absence of interior floor drains. A sampling of the resulting conditions include: foundation movement and cracking and floor slab failures.

The exterior masonry bearing wall assemblies are in fair to poor conditions. Because of localized movement and absence of masonry control joints, full depth step masonry cracking is present. Furthermore, the unheated nature of the structure, large temperature swings in the exterior walls likely also contribute to masonry cracking.

The roof structure is in fair to good condition. There exists some moisture staining, however, roof lines seems generally straight and true without overly concerning creep (deflection).

The roof coverings are a manufactured slate and have exceeded their useful service life. The aluminum gutters and downspouts are in fair condition, however, absent of adequate storm water management at grade. The existing painted wood fascia is in fair condition.

The window assemblies are in poor condition and may be beyond reasonable repair. The residential quality overhead door assemblies are in fair to poor condition. The wood jamb material is in fair to poor condition. A reasonably new single man door is in good condition.

Fairgrounds West Recommendations: *A comprehensive building rehabilitation is recommended. Additionally, a respectful approach to the history of the structure is also expressed as an alternative.*

- *Repair of existing foundations assemblies.*
- *Replacement of interior floor assemblies. Because formal plumbing systems do not exist, implementation of interior floor drains is not considered here. Water management would be accomplished by improved slap slope and mitigation of storm water influence.*
- *Exterior masonry bearing wall repairs including: tuckpointing, brick replacement, and movement joint installation. In respect to historical sensitive rehabilitation approach, further attention would be required.*
- *Roof rehabilitation including: roof covering replacement, gutter and downspout replacement, and fascia rehabilitation. This may also include minor roof deck and roof framing repairs. In respect to historical sensitive rehabilitation approach, further attention would be required.*

- *Replace overhead door and windows. This will also include rehabilitation of existing architectural woodwork. In respect to historical sensitive rehabilitation approach, further attention would be required.*
- *All interior and exterior painted finishes should be rehabilitated. Equipment/furnishings will require removal and reinstallation.*

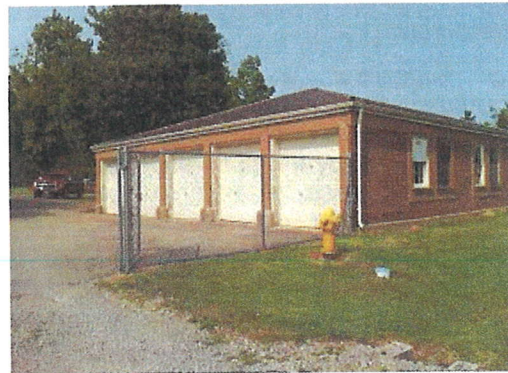
Fairgrounds East: This 2050sf structure is in poor condition with various building systems and/or assemblies in various degrees of disrepair and deterioration. For all intents and purposes the observations made of the west building apply here with some exceptions. Overall, the east structure is in worse shape than the west.

There are three notable conditional differences between these structures.

- General maintenance of the building is not that of the west structure attributing to an overall worse condition.
- A section of interior concrete floor slab has already been replaced.
- There exists pronounced foundation settlement on the southwest corner of this structure.

Fairgrounds East Recommendations: *A comprehensive building rehabilitation is recommended. Additionally, a respectful approach to the history of the structure is also expressed as an alternative. The specific recommendations for the west building apply here with the addition of the following items.*

- *Replace two existing man doors.*
- *Repair existing foundation settlement.*

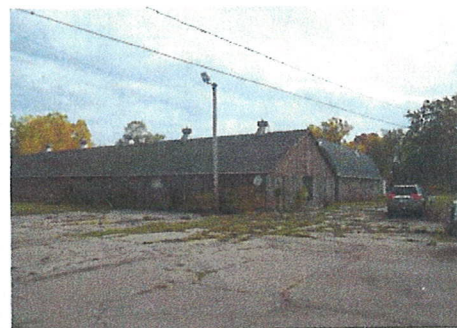
This 8,100sf structure is in poor to unsafe condition. For the most part, the structure appears essentially abandoned and is home to long term storage. We understand that at some period in its history, it was utilized for dairy production.

At some point, the building was adapted for a change of use. The project included implementation of ventilation systems and thermal improvements. In addition, some significant structural modifications.

Parkside Recommendations (Respecting the History): Complete historic structures report to determine restoration project scope.
