# ***Roof Evaluation and Budgetary Estimate***

Orrin King Building – 448 Algoma Boulevard, Oshkosh

**Report/Proposal Date:** July 21, 2017

**Prepared by:** Oshkosh Industrial Roofing & Sheetmetal, LLC.  
P.O. Box 1  
Winnebago, WI 54985

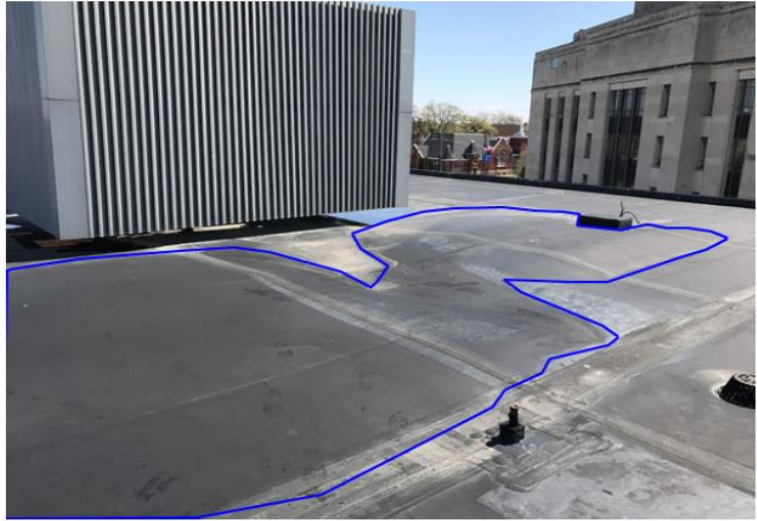
## Image #1 – Defect 1

Note: There is a large area of detached insulation, evident as a protruding blister.

The area of detached insulation is susceptible to wind uplift forces, and could cause a catastrophic loss in the event of a windstorm.

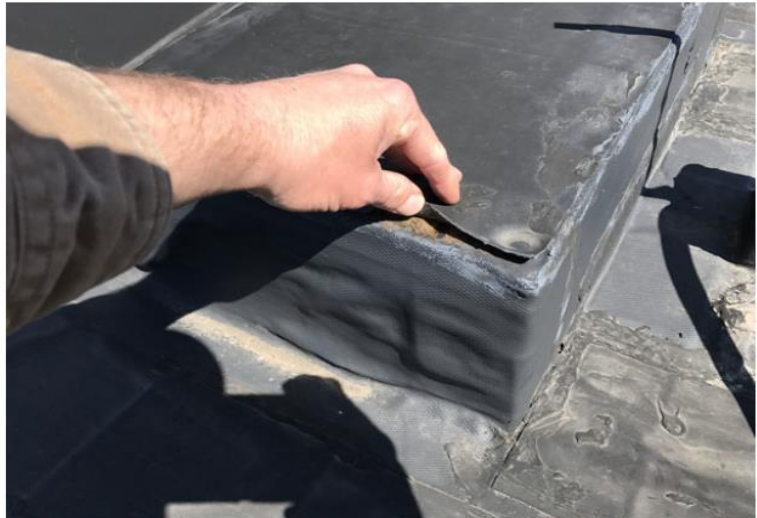
## Image #2 – Defect 2

Note: Seams and flashings on this roof exhibit aging. The glue on this coverpatch has deteriorated and is separating from the substrate.

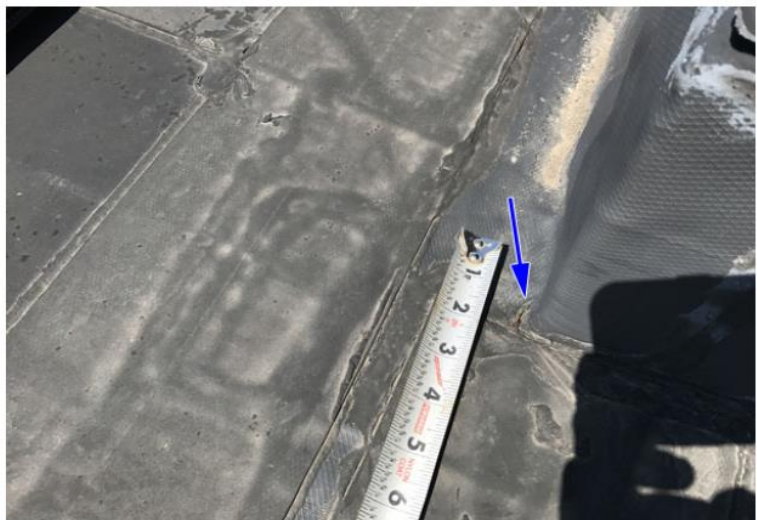
## Image #3 – Defect 2 (Continued)

Note: Aging flashings on this roof exhibit weatherchecking and dry rot. There is a hole into the roof system at the base of this curb.

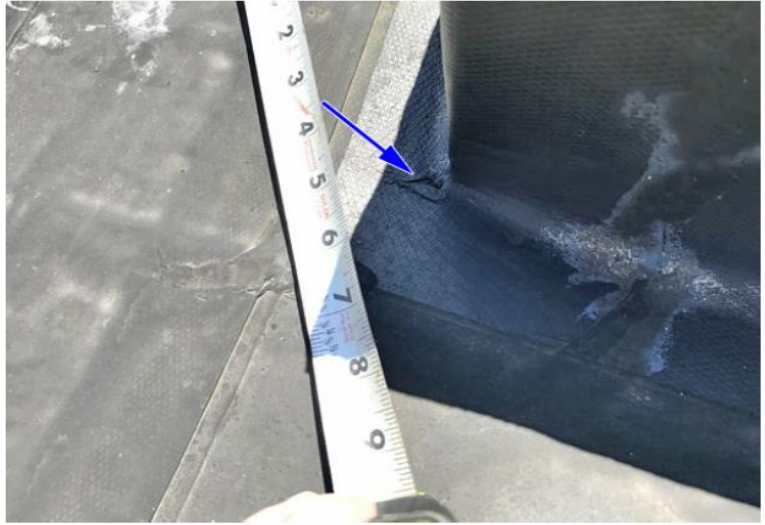
**Image #4 – Defect 3 (Continued)**

Note: Aging flashings on this roof exhibit weatherchecking and dry rot. There is a hole into the roof system at the base of this curb.

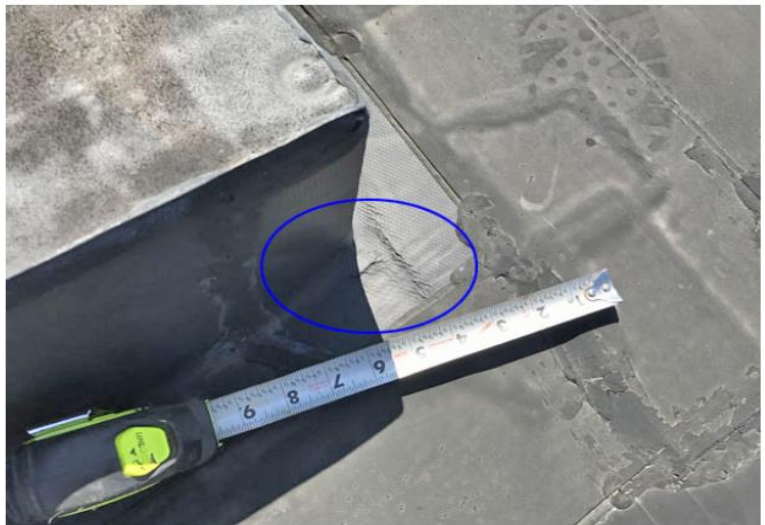
**Image #5 – Defect 3 (Continued)**

Note: Aging flashings on this roof exhibit weatherchecking and dry rot. There is a hole into the roof system at the base of this curb.

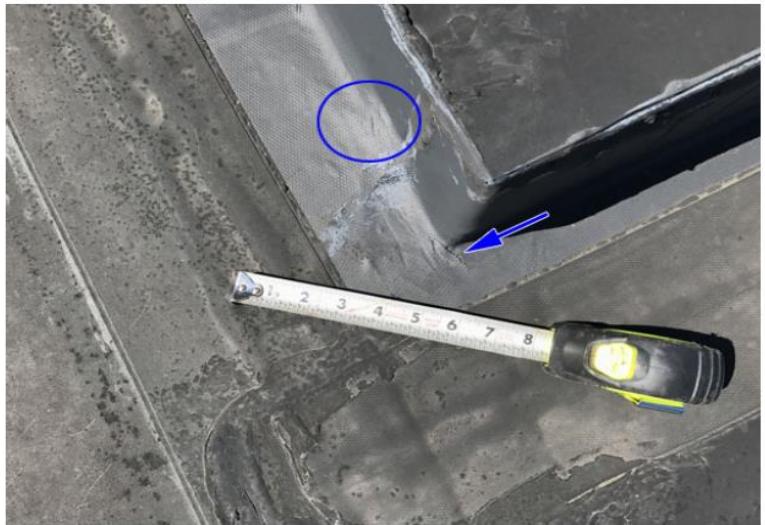
**Image #6 – Defect 3 (Continued)**

Note: Aging flashings on this roof exhibit weatherchecking and dry rot. There is a hole into the roof system at the base of this curb.

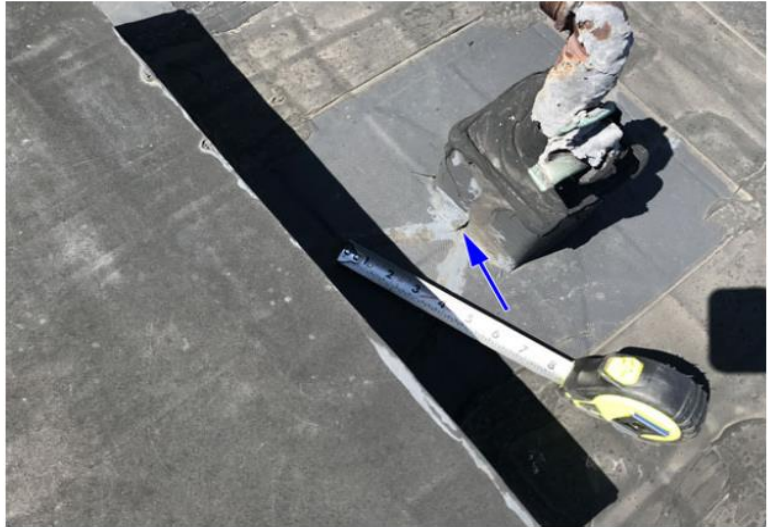
**Image #7 – Defect 3 (Continued)**

Note: Aging flashings on this roof exhibit weatherchecking and dry rot. There is a hole into the roof system at the base of this pitchpocket.

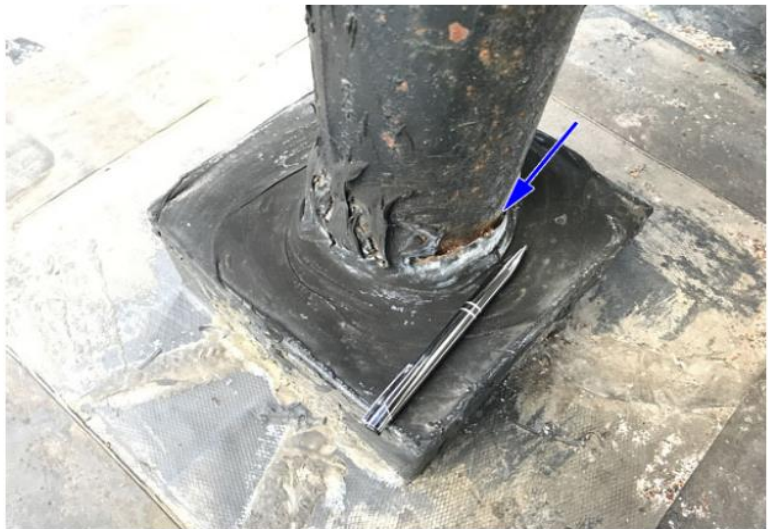
**Image #8 – Defect 4**

Note: The equipment stand sealer pockets have detached from the pipes due to rusting.

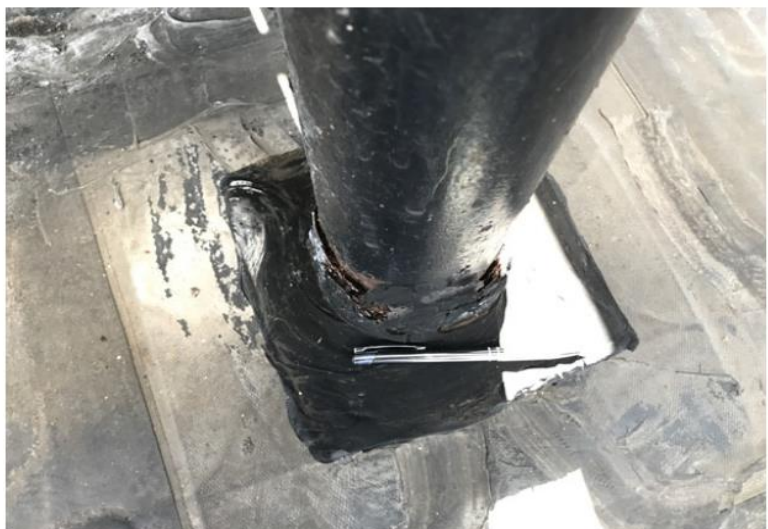
**Image #9 – Defect 6 (Continued)**

Note: The equipment stand sealer pockets have detached from the pipes due to rusting.

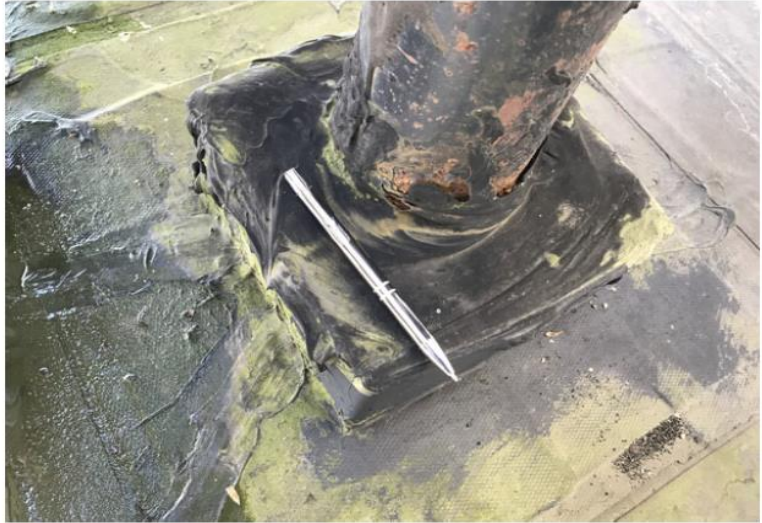
**Image #10 – Defect 6**

Note: The equipment stand sealer pockets have detached from the pipes due to rusting.

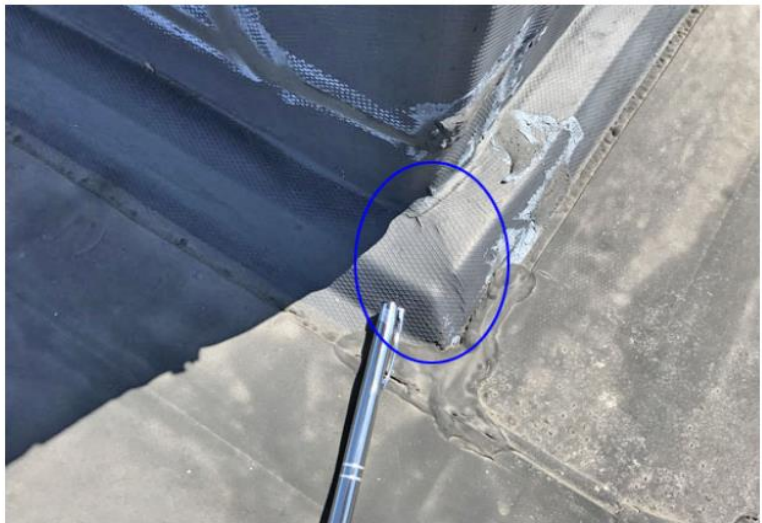
**Image #11 – Defect 7 (Continued)**

Note: Aging flashings on this roof exhibit weatherchecking and dry rot. There is a hole into the roof system at the base of this curb.

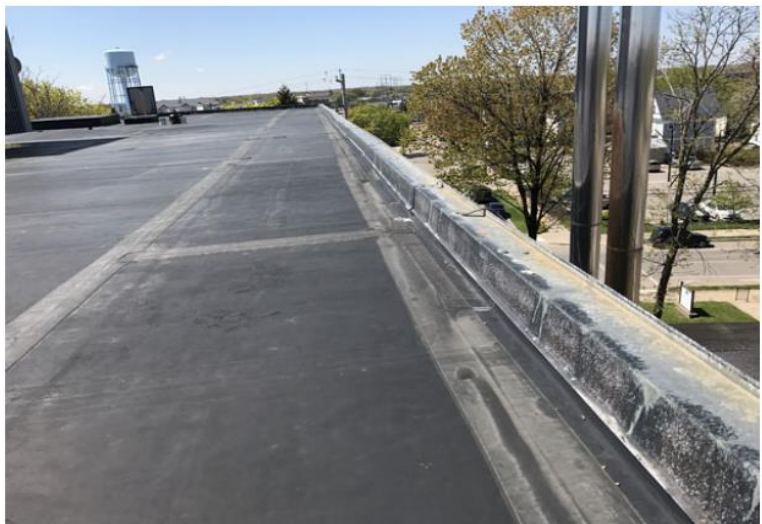
**Image #12 – Defect 8 (Overview)**

Note: There are numerous issues with the coping cap and wall base. The original flashing material is weatherchecked, and at the end of its service life. The coping seam cover sealant is deteriorated and likely permits water into the copings.

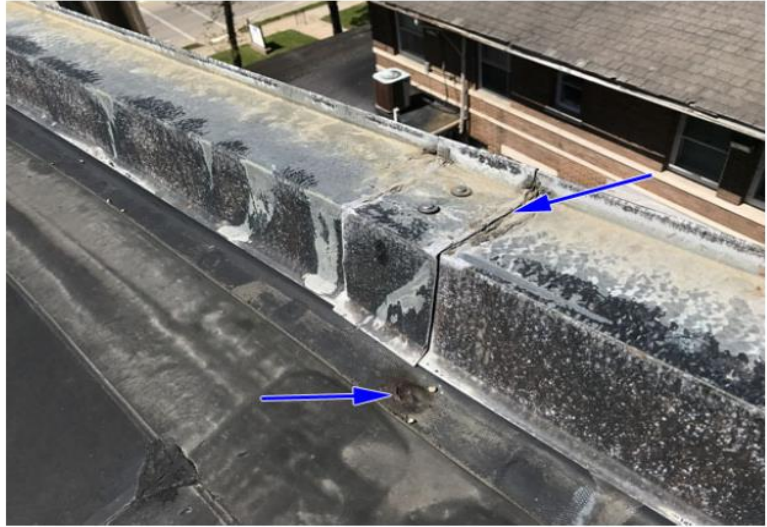
**Image #13– Defect 8 (Detail)**

Note: Coping seam cover sealant is suspect, and the EPDM flashing material below is aging and weatherchecked. The lower arrow indicates a hole through the flashing..

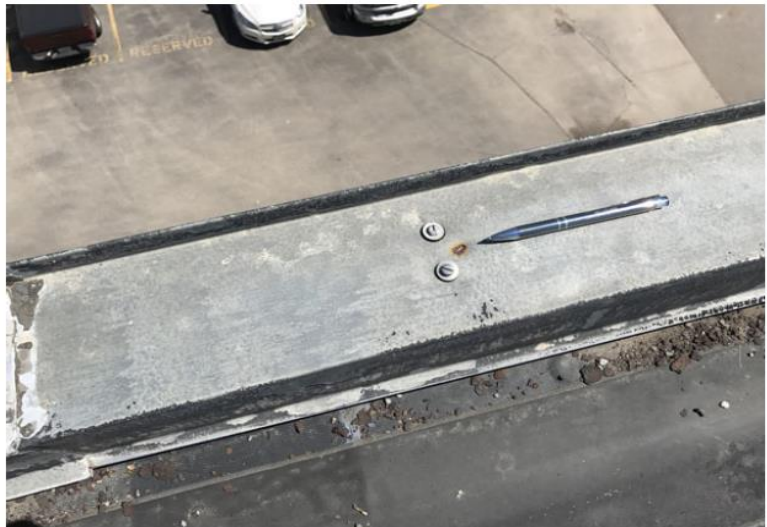
**Image #14 – Defect 9**

Note: Hole in coping cap metal.

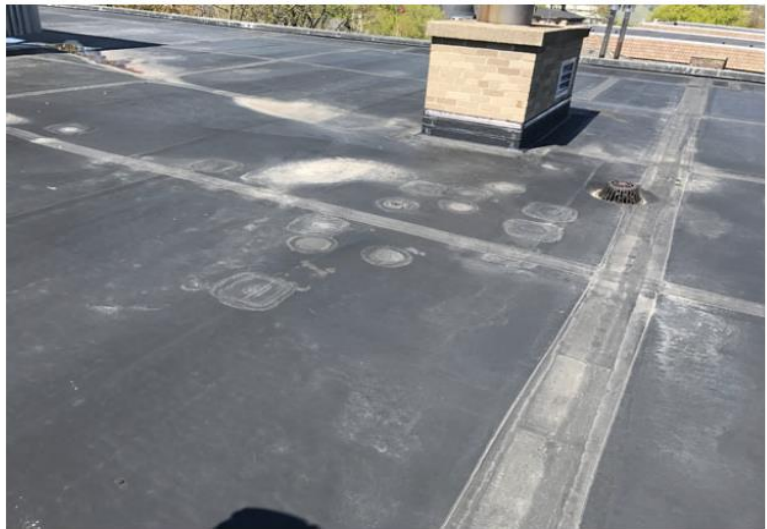
**Image #15 – Defect 10 (Continued)**

Note: There are numerous prior repairs and patches in Area 10.

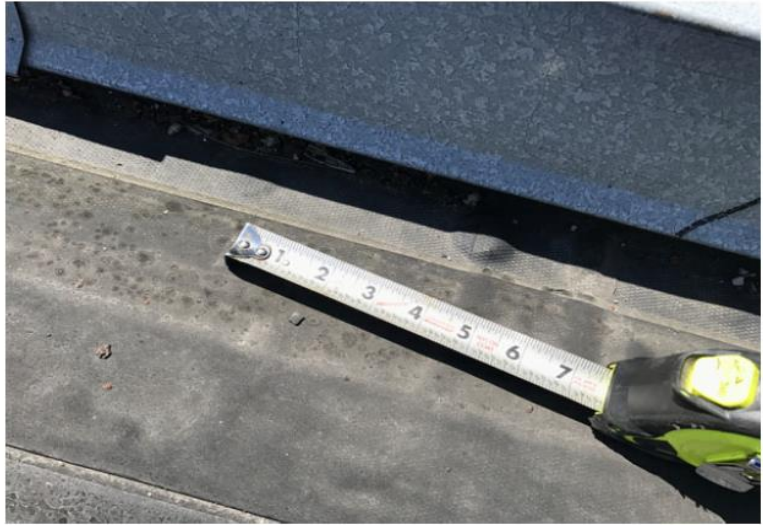
#### Image #16 – Defect 11

Note: Flashing material at the base of the copings is aging and weatherchecked. The protruding fastener head at the base of the wall will be a source of water entry.

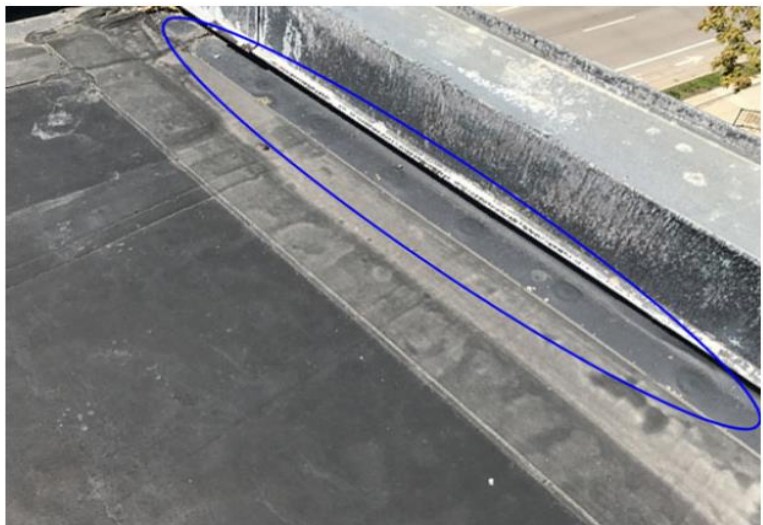
#### Image #17 – Core Sample 1

Note: There are numerous protruding fastener heads at the base of the coping, all exist under the weatherchecked EPDM flashing.

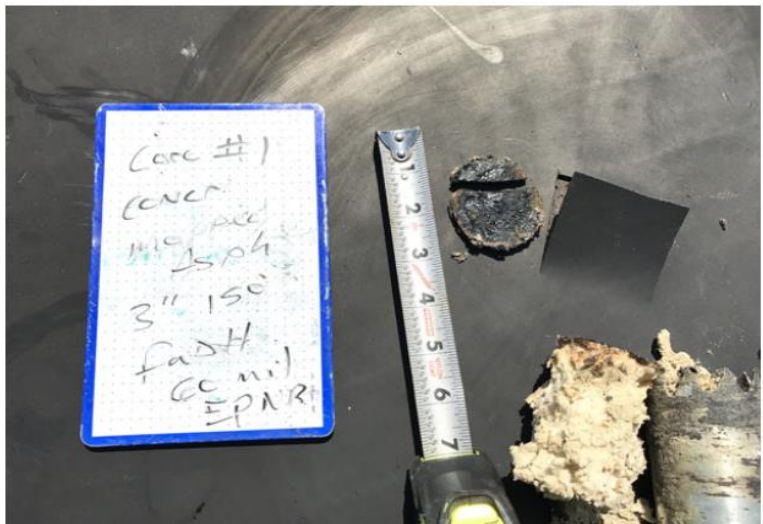
#### Image #18 – Core Sample 1

Note: The sample collected at Core #1 consists of one layer of 3" thick polyisocyanurate board insulation mopped to the concrete deck.

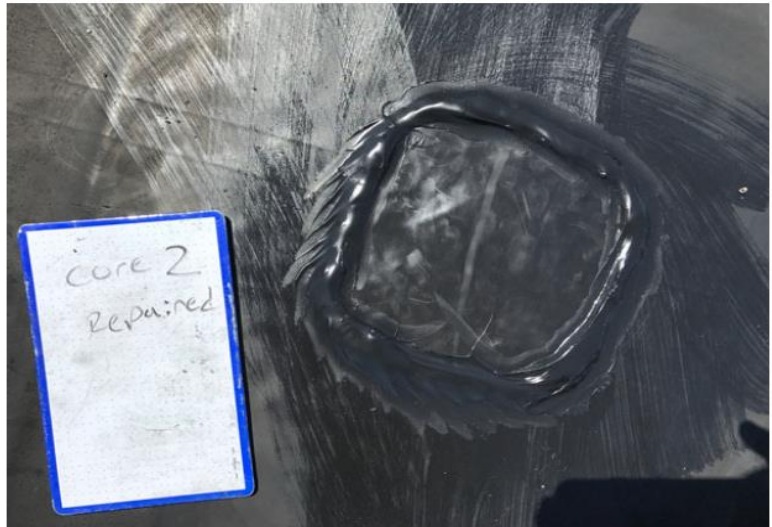
### Image #20 – Core Sample 2 Repair

Note: Core #2 consisted of the same materials as Core #1.

The core sample location was repaired properly using appropriate materials and methods.

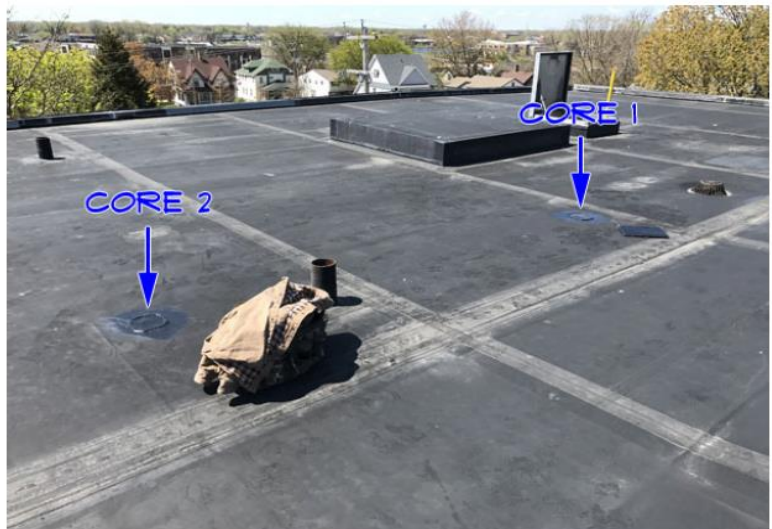
### Image #20 – Core Sample Repair Overview

Note: The core sample locations are located on the south end of the building, on the east side of the drain.
