4. ROOF REPLACEMENT PROGRAM - FACILITIES

Roof Evaluation and Budgetary Estimate

Orrin King Building – 448 Algoma Boulevard, Oshkosh

Report/Proposal Date: July 21, 2017

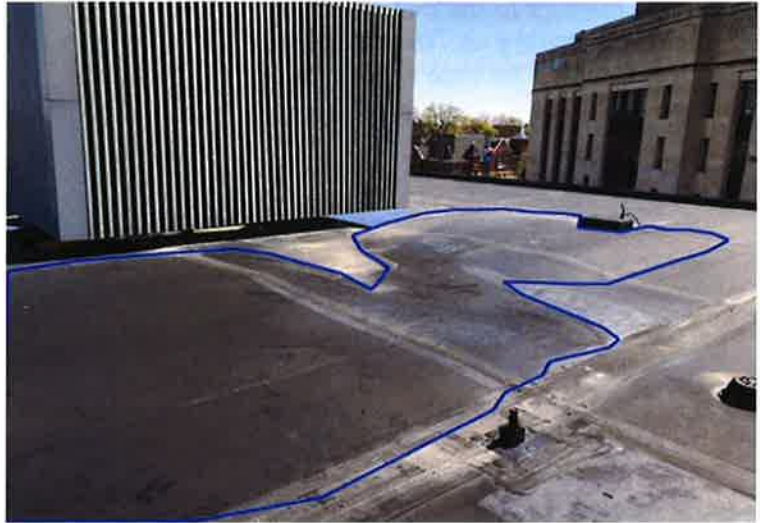
Image #1 – Defect 1

Note: There is a large area of detached insulation, evident as a protruding blister.

The area of detached insulation is susceptible to wind uplift forces, and could cause a catastrophic loss in the event of a windstorm.

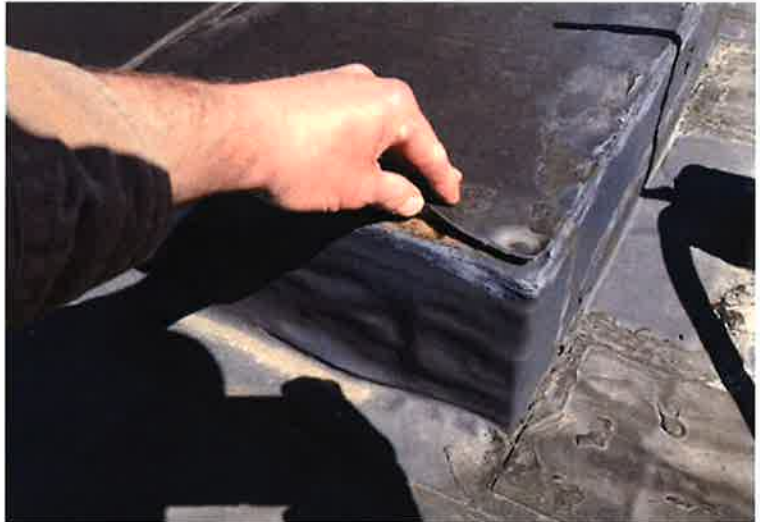
Image #2 – Defect 2

Note: Seams and flashings on this roof exhibit aging. The glue on this coverpatch has deteriorated and is separating from the substrate.

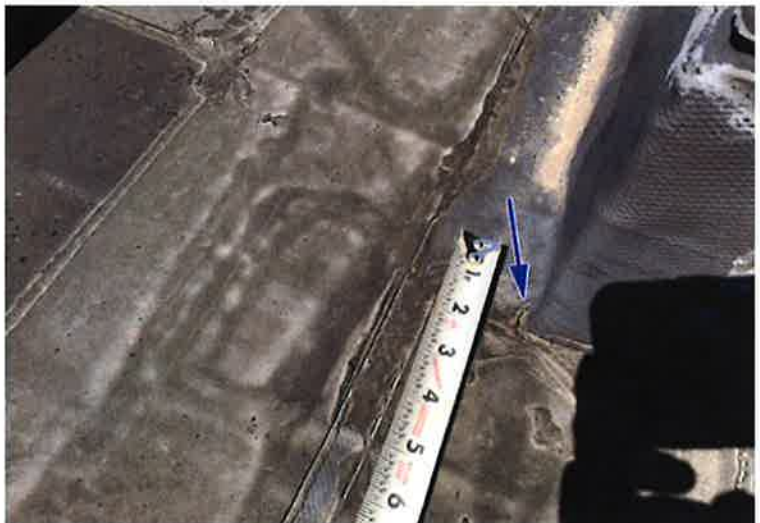
Image #3 – Defect 2 (Continued)

Note: Aging flashings on this roof exhibit weatherchecking and dry rot. There is a hole into the roof system at the base of this curb.

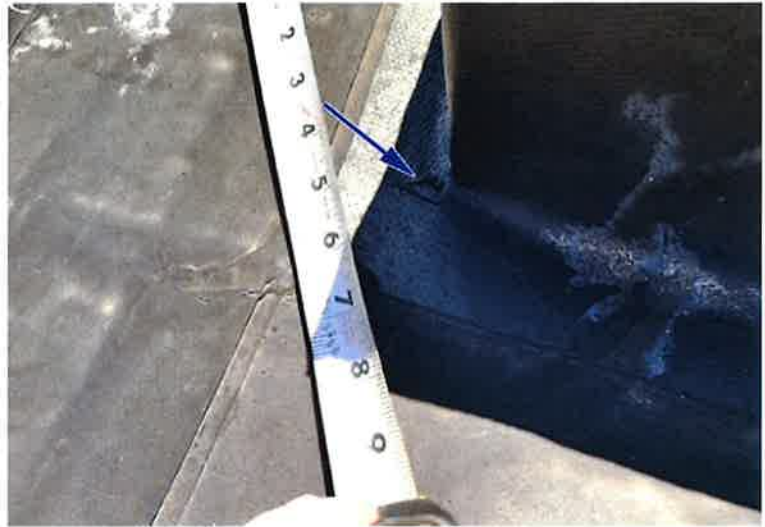
Image #4 – Defect 3 (Continued)

Note: Aging flashings on this roof exhibit weatherchecking and dry rot. There is a hole into the roof system at the base of this curb.

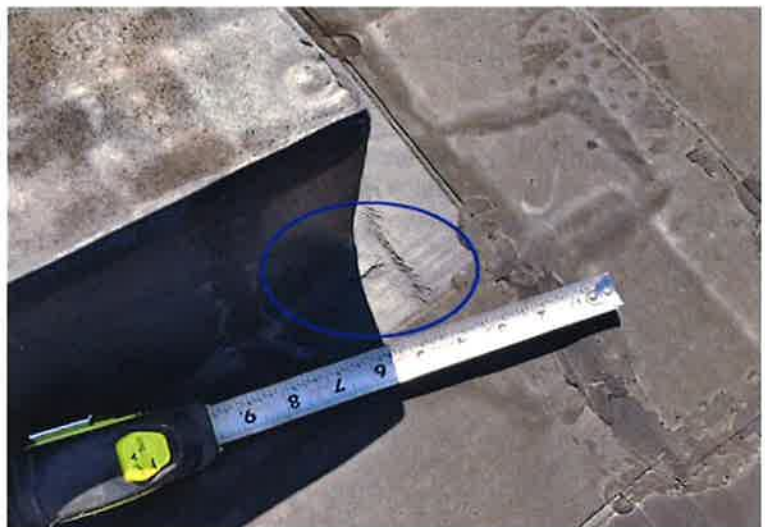
Image #5 – Defect 3 (Continued)

Note: Aging flashings on this roof exhibit weatherchecking and dry rot. There is a hole into the roof system at the base of this curb.

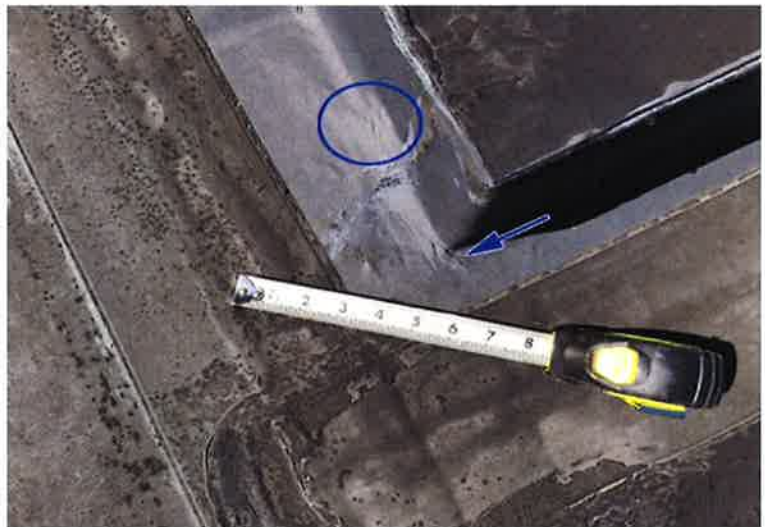
Image #6 – Defect 3 (Continued)

Note: Aging flashings on this roof exhibit weatherchecking and dry rot. There is a hole into the roof system at the base of this curb.

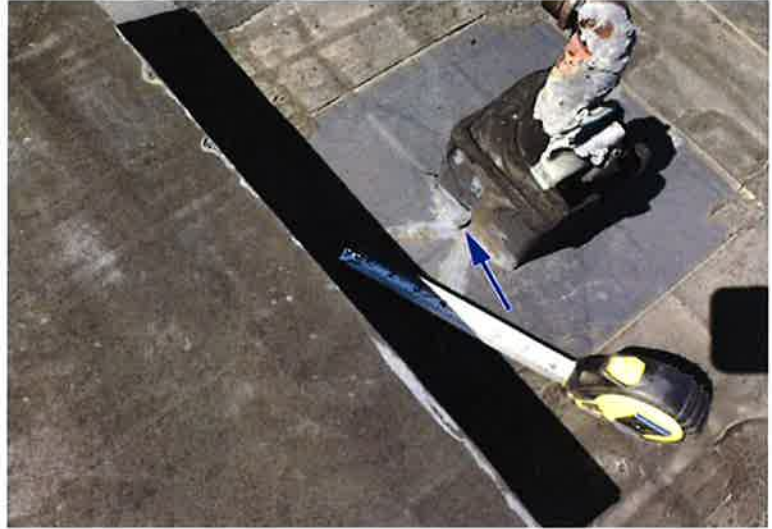
Image #7 – Defect 3 (Continued)

Note: Aging flashings on this roof exhibit weatherchecking and dry rot. There is a hole into the roof system at the base of this pitchpocket.

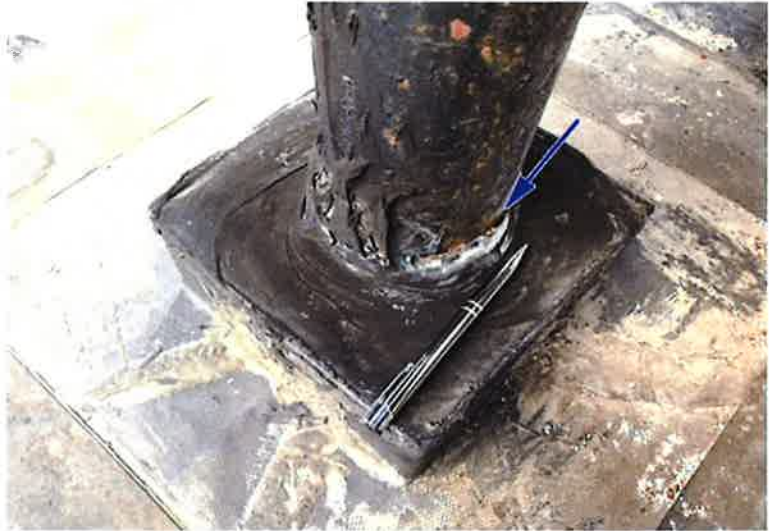
Image #8 – Defect 4

Note: The equipment stand sealer pockets have detached from the pipes due to rusting.

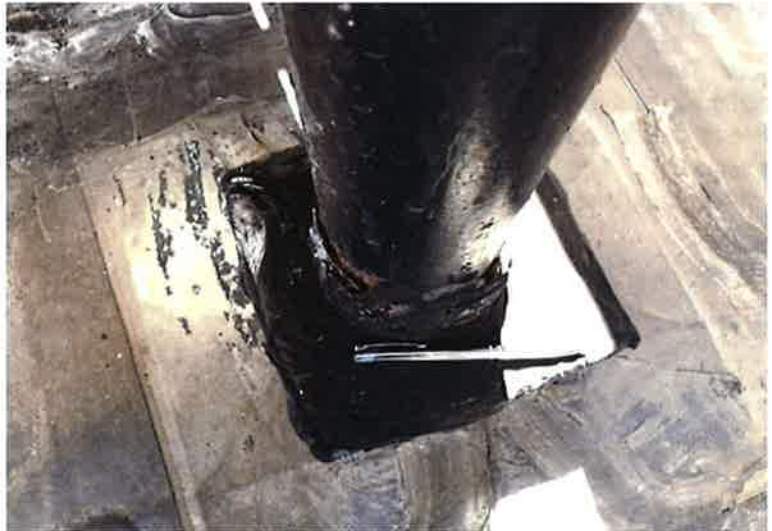
Image #9 – Defect 6 (Continued)

Note: The equipment stand sealer pockets have detached from the pipes due to rusting.

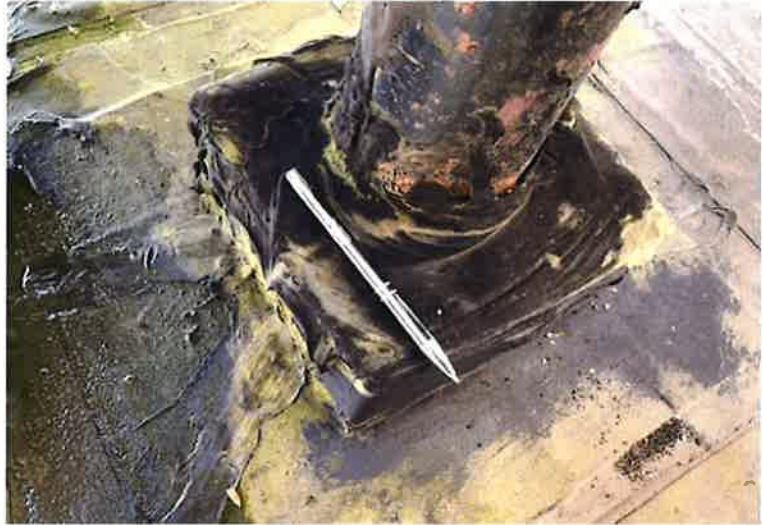
Image #10 – Defect 6

Note: The equipment stand sealer pockets have detached from the pipes due to rusting.

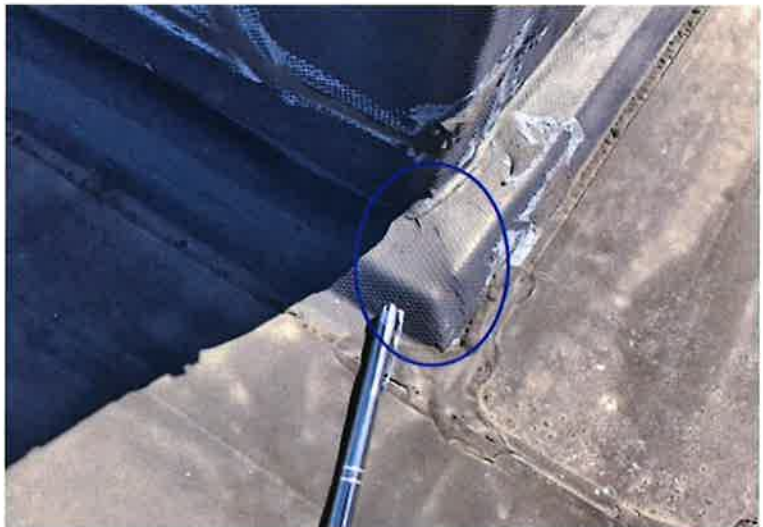
Image #11 – Defect 7 (Continued)

Note: Aging flashings on this roof exhibit weatherchecking and dry rot. There is a hole into the roof system at the base of this curb.

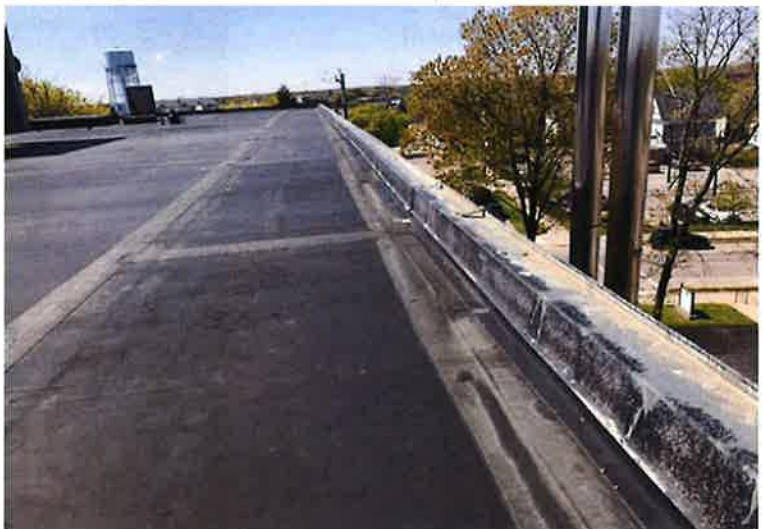
Image #12 – Defect 8 (Overview)

Note: There are numerous issues with the coping cap and wall base. The original flashing material is weatherchecked, and at the end of its service life. The coping seam cover sealant is deteriorated and likely permits water into the copings.

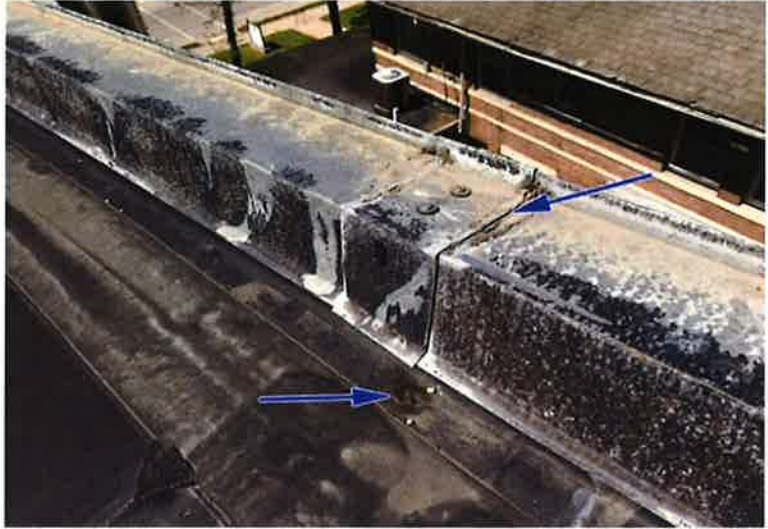
Image #13– Defect 8 (Detail)

Note: Coping seam cover sealant is suspect, and the EPDM flashing material below is aging and weatherchecked. The lower arrow indicates a hole through the flashing..

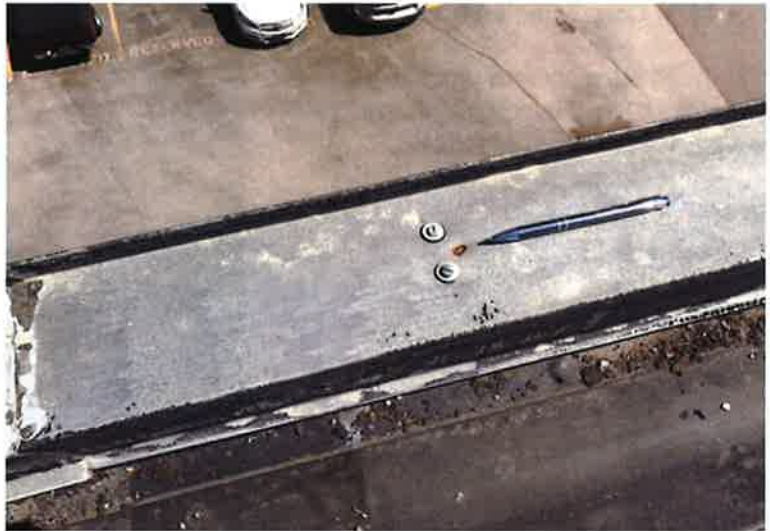
Image #14 – Defect 9

Note: Hole in coping cap metal.

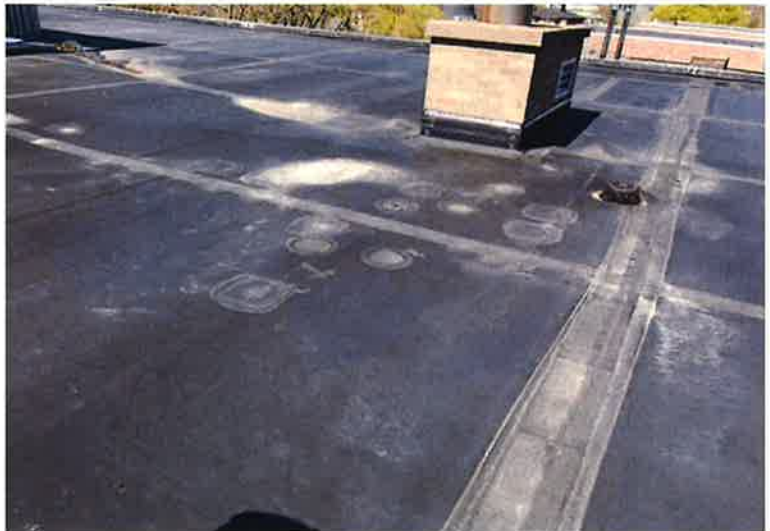
Image #15 – Defect 10 (Continued)

Note: There are numerous prior repairs and patches in Area 10.

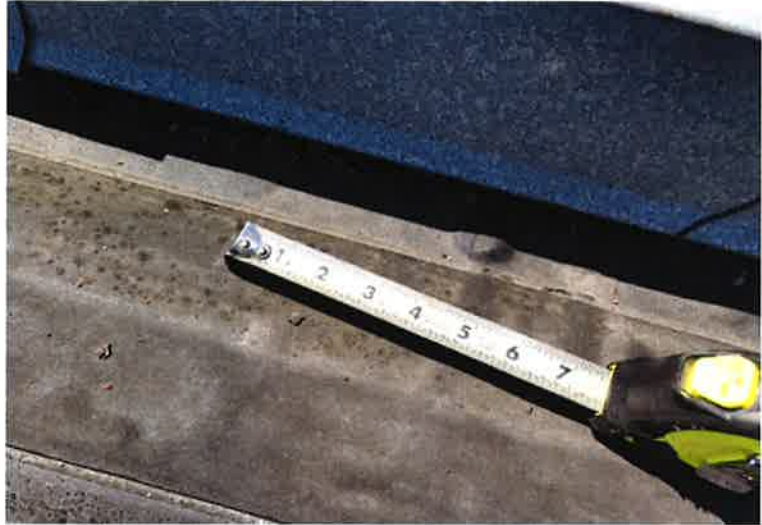
Image #16 – Defect 11

Note: Flashing material at the base of the copings is aging and weatherchecked. The protruding fastener head at the base of the wall will be a source of water entry.

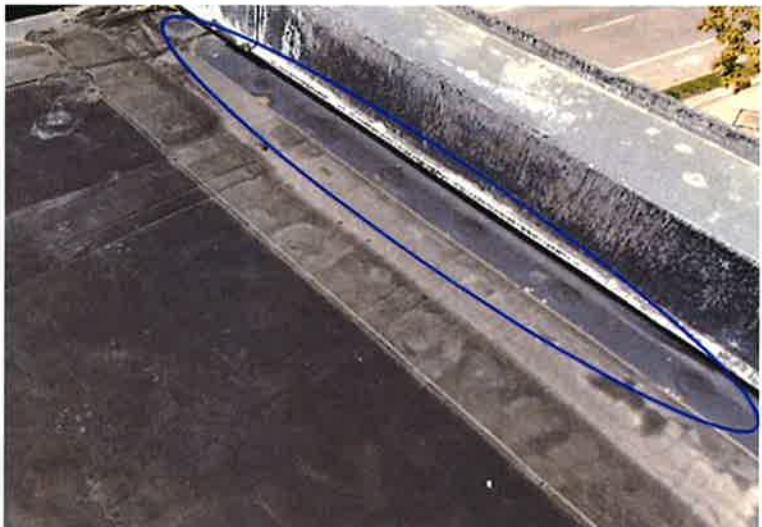
Image #17 – Core Sample 1

Note: There are numerous protruding fastener heads at the base of the coping, all exist under the weatherchecked EPDM flashing.

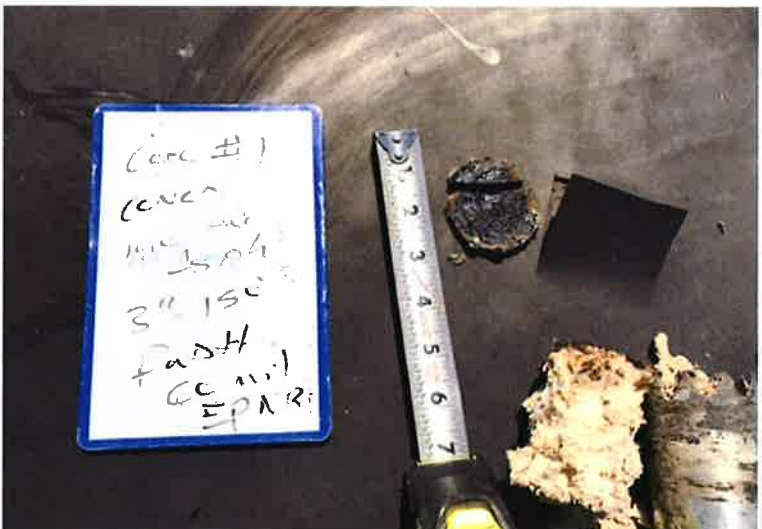
Image #18 – Core Sample 1

Note: The sample collected at Core #1 consists of one layer of 3" thick polyisocyanurate board insulation mopped to the concrete deck.

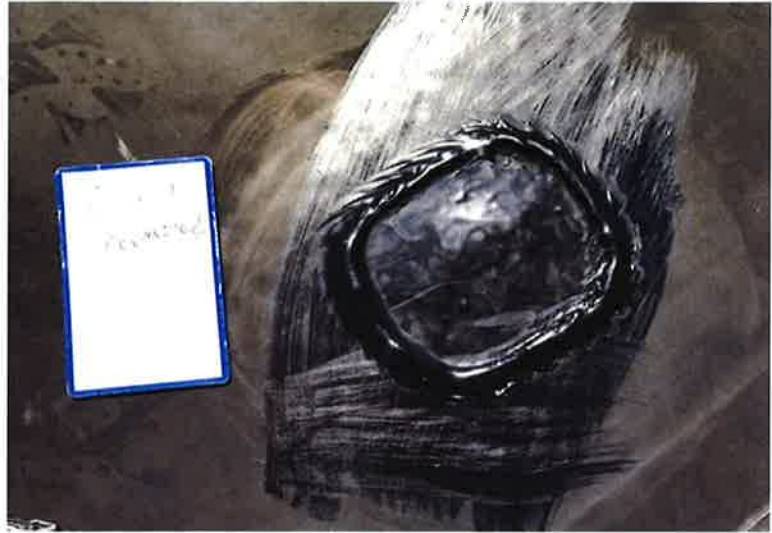
Image #19 – Core Sample 2

Note: The core sample location was repaired properly using appropriate materials and methods.

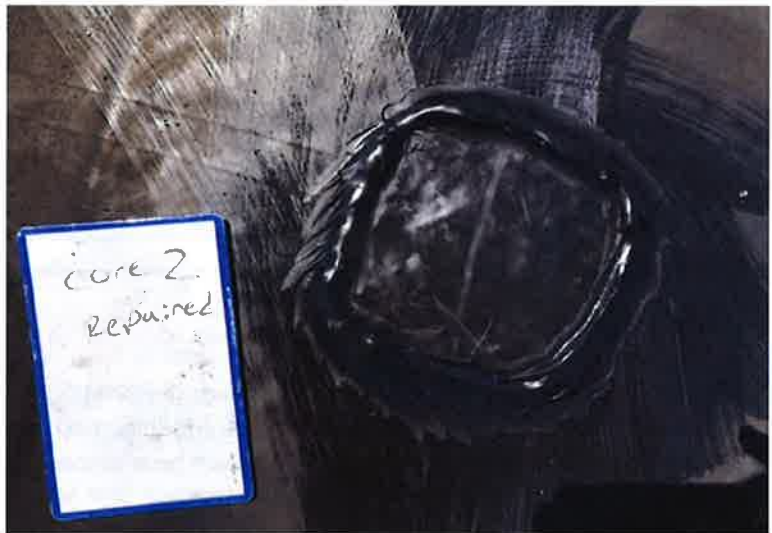
Image #20 – Core Sample 2 Repair

Note: Core #2 consisted of the same materials as Core #1.

The core sample location was repaired properly using appropriate materials and methods.

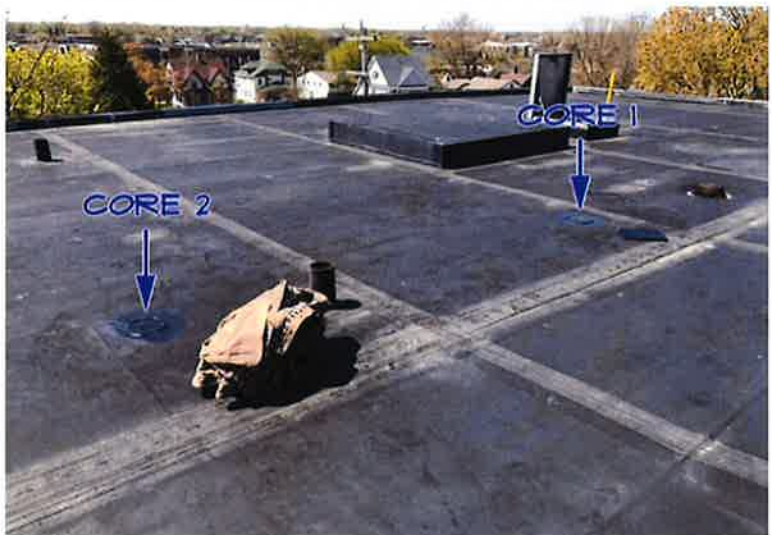
Image #20 – Core Sample Repair Overview

Note: The core sample locations are located on the south end of the building, on the east side of the drain.
