Facility Condition Assessment

WINNEBAGO COUNTY, WI

SEPTEMBER 2023 (VERSION 1.0)

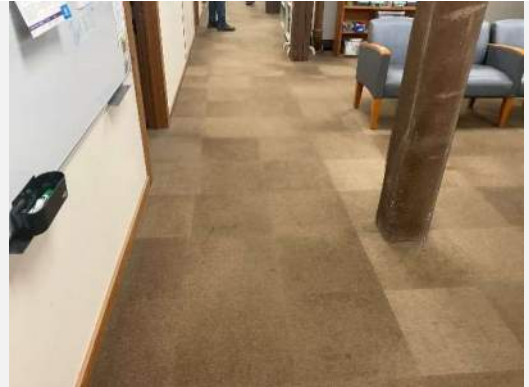
1. County Administration Building - Carpeting

Most of the carpet squares on the second floor of the County Administration Building are very worn and discolored and should be scheduled for replacement.

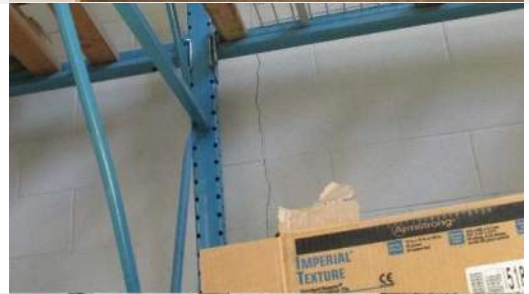
2. County Administration Building - Wall Cracks

There are multiple large cracks on the interior CMU wall in the warehouse. These cracks should be monitored to ensure major structural issues are not occurring. Facility staff is already aware of this Issue.

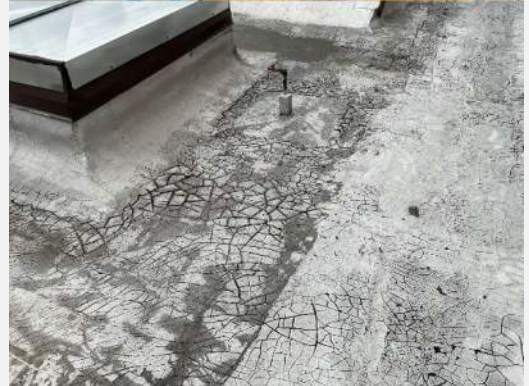
3. County Administration Building - Roofing

As evident by the significant cracking of the built-up roofing, the County Administration Building roof should be planned to be replaced within the next couple of years.

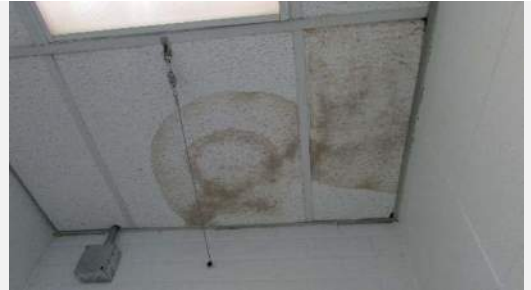
1. Main Facilities Building - Water Damage

There are approximately three water-stained ceiling tiles in the corridor connection between the Office and the Shop Area. These ceiling tiles should be replaced and the roof, as the presumable source of water infiltrating into the building, should be repaired.

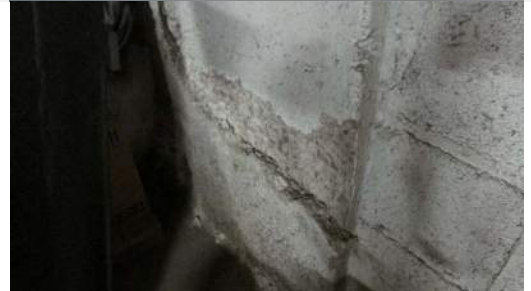
2. Main Facilities Building – CMU Damage (1 of 2)

A masonry support has cracked, and various CMUs in the North Garage are crumbling at the base of the wall. Staff has indicated that this may be due to blasting at the nearby quarry. These cracks should be monitored for major changes or growth that could be indicative of structural failure.

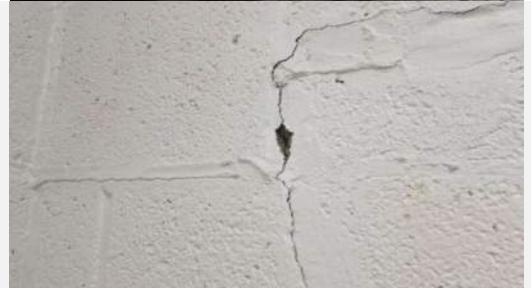
3. Main Facilities Building - CMU Damage (2 of 2)

In addition to the masonry elements illustrated above, cracks have developed in both the Men's and Women's Locker Rooms on second floor.

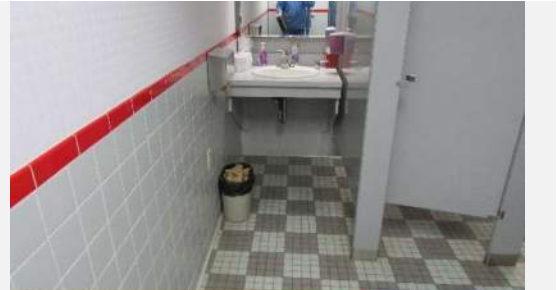
1. Office/Garage - Accessibility

The width between the toilet partition and the wall is 24" which is inadequate for accessible use of the sink in the Women's accessible (Office Area) Toilet Room. Additionally, there is no pipe wrap under any sinks in the accessible Men's and Women's Toilet Rooms.

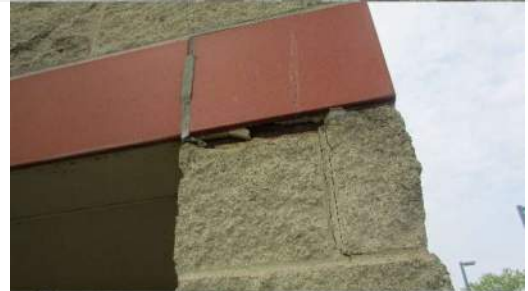
2. Office/Garage - Exterior Wall Deterioration

A Northeast exterior wall corner section near the Office Area needs to be repaired.

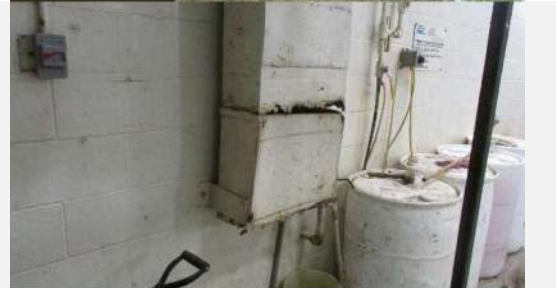
3. Office/Garage – Wash Bay Exhaust Ductwork

Due to the high moisture content of the wash bay environment, the existing exhaust ductwork has corroded and deteriorated to the point where the sheet metal has begun to split. Recommend installation of stainless-steel replacements in the wash bay area.

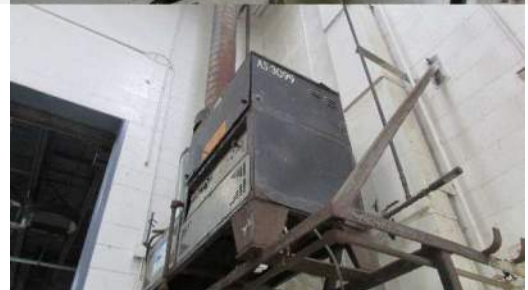
4. Office/Garage – Wash Bay Heated Pressure Washer

Due to the high moisture content of the wash bay environment, there is extensive corrosion on the elevated heated pressure washer. It is recommended that this unit be replaced and relocated directly outside of the wash bay area.

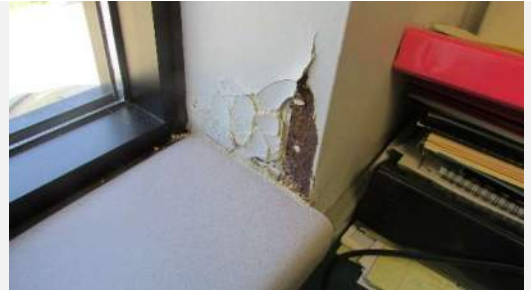
1. Neenah Human Services - Water Intrusion Damage

There are numerous walls, predominately on the second floor, that have water intrusion damage and need to be repaired.

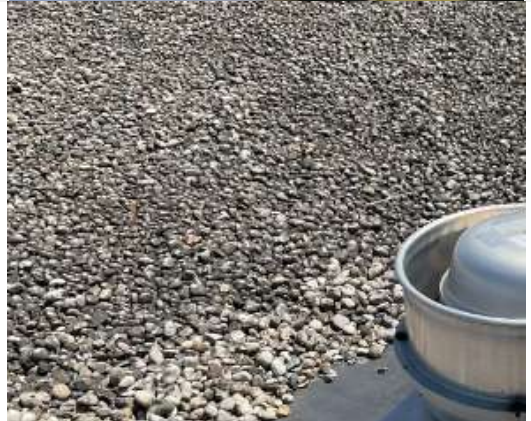
2. Neenah Human Services - Roof

The roof of the Neenah Human Services is original to the 1994 facility and needs replacement. Facilities Staff is aware of this requirement and is in the process of budgeting for its replacement.

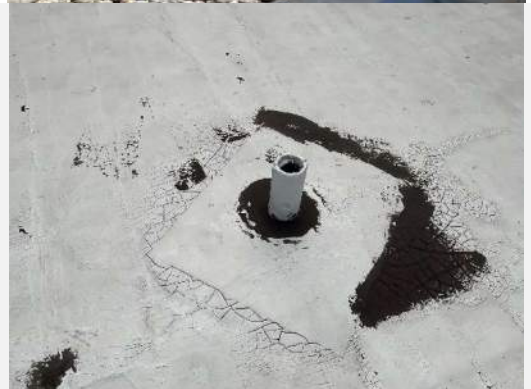
3. Second Chance - Roof

There is significant cracking of the built-up roof at the Second Chance facility along with areas of the roof showing locations of residual standing water. This roof should be replaced.

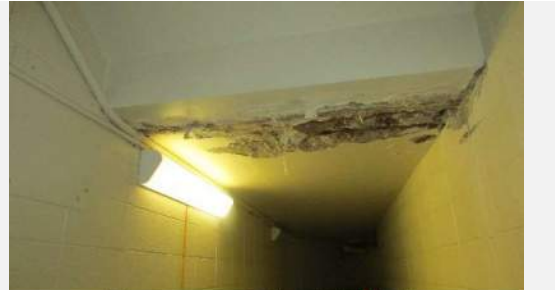
1. Tunnels – Condition / Usage

During on-site visit, both tunnels either had air quality issues and/or water damage issues. In the case with both tunnels, it is recommended that pedestrian use of these tunnels be limited, and a further study be conducted to determine air quality and structural integrity prior to any future potential use as by staff/personnel.

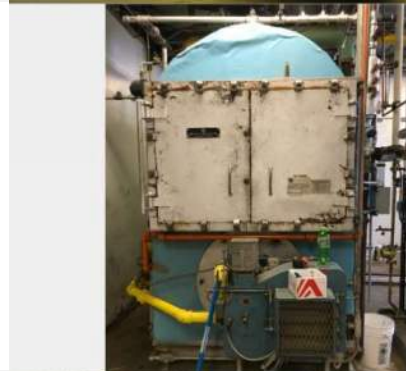
2. Courthouse – Aging Boilers

The County has done a good job of updating aspects of the HVAC infrastructure within the past few years at the Courthouse. This also includes boiler repair projects in 2002. Although fully functional, and even with repairs in 2002, the boilers in the Courthouse basement are believed to be approximately 66 years old and have exceeded their expected useful lives.

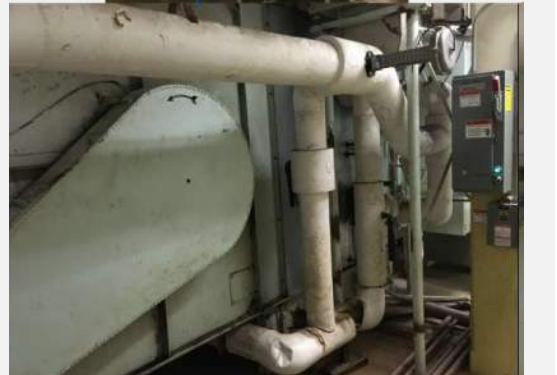
3. Orrin King Building – Ventilation System

Although functional, the primary air handling unit installed in approximately 1967, which provides heating, ventilation and air conditioning to the facility, has exceeded its expected useful life.

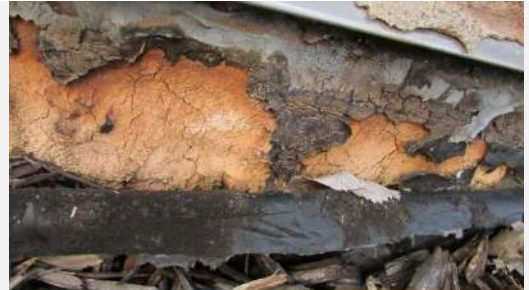
1. Park View Health Center – EIFS Failures

Per Facility Staff, exterior insulation finishing system (EIFS) has been failing in multiple areas. To date, this is being replaced with metal panel system as failure occurs.

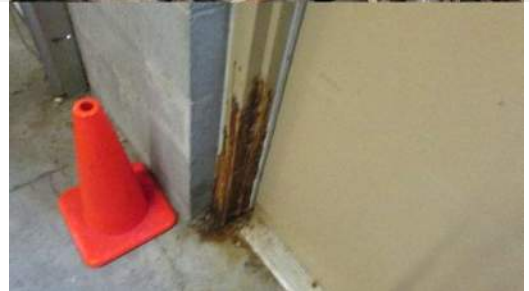
2. Park View Health Center – Pedestrian Doorframe

The pedestrian doorframe in the garage has substantial corrosion and needs to be repaired or replaced. As mentioned in Observation #4 below, when feasible, consider the installation of stainless-steel door frames in areas where substantial salt use during the Winter is required.

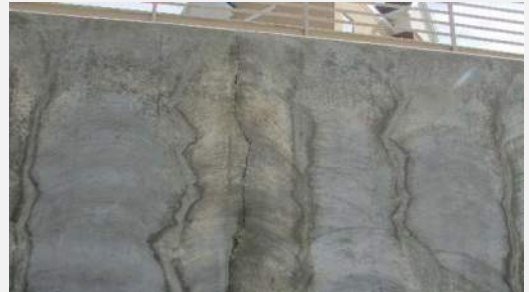
3. Park View Health Center – Loading Dock Retaining Wall

Vertical cracks have begun to form on the loading dock retaining wall. Although there does not appear to be any issues with the cracks or any substantial heaving of these walls, it is recommended that this be monitored and addressed if cracks become larger and/or walls begin to heave.

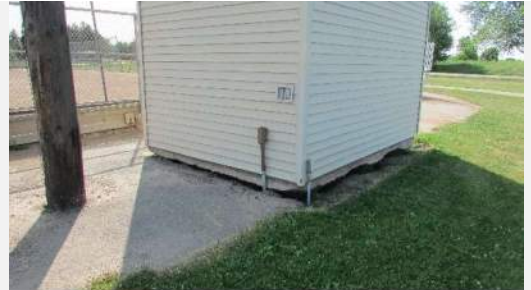
1. Community Park Scoring Tower #2 - Foundation

The entire perimeter of the concrete slab supporting the structure has deteriorated. Although the structure still appears to be fully vertical, it is recommended that appropriate repairs occur to maintain structural integrity.

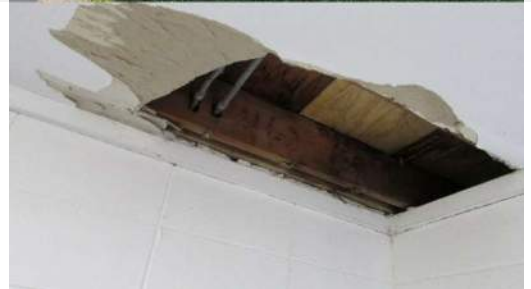
2. Community Park Restroom Shelter #2 - Ceiling Damage

Ceiling sections need repair in both Men's and Women's Toilet Rooms. The photo illustrates a large hole in the ceiling of Men's Toilet Room.

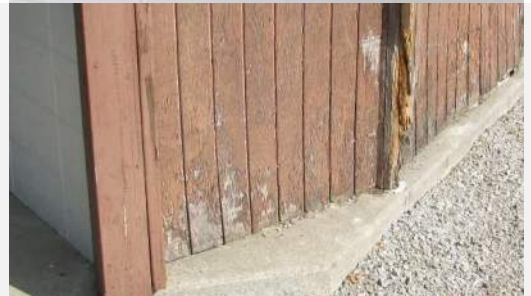
3. Community Park Octagon Shelters #3 & #4 – Exterior Siding

Wood siding for both Octagon Shelter #3 and #4 is weathered and in need of replacement. Most of the damage has occurred near the base.

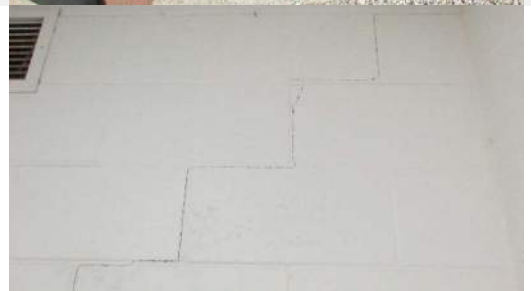
4. Expo Site Toilet Building

Women's showers (North) have an extensive crack along the mortar joint of the CMU, additionally the wall/floor intersection needs to be re-caulked in both North & South Toilet Rooms.

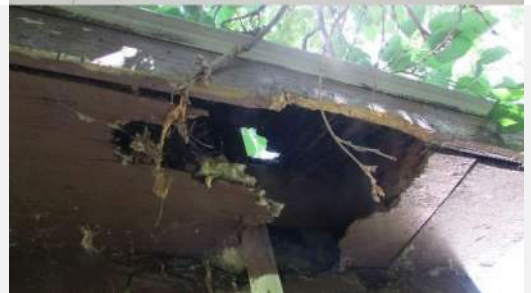
5. Black Wolf Pump House – Damaged Soffit & Roof

There is a significant hole in both the soffit and the roof of the Black Wolf Pump House that requires repairs.

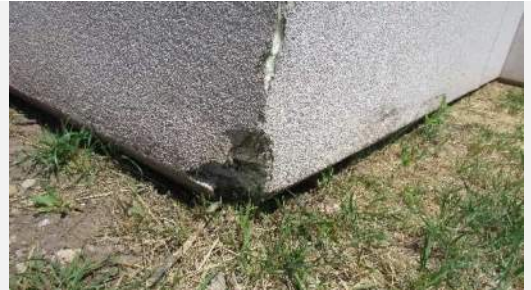
1. Sand Pit Radio Tower – EIFS Damage

Exterior insulation finishing system (EIFS) panels damaged at outside corners should be repaired. It was also noted that sealant joints are failing and should be repaired.

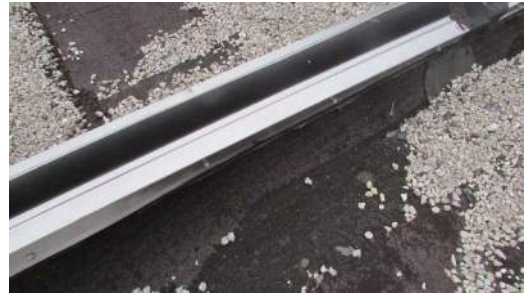
2. Law Enforcement Center (Main Building) - Roof

A few locations of the roof have exposed roofing underlayment, some blistering and cracking is occurring at roof edges near the expansion joints. Areas of moss growth in the corners indicate residual water accumulation and inadequate roof pitch. These locations should be periodically monitored and repaired as required.

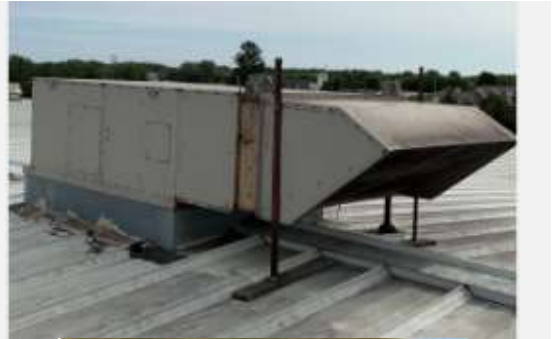
1. Material Transfer Station – Ventilation Equipment

Staff commented that the make-up air units on the roof of the Material Transfer Station are no longer functional. There is also corrosion occurring on these units. See comment in Observation #6 below.

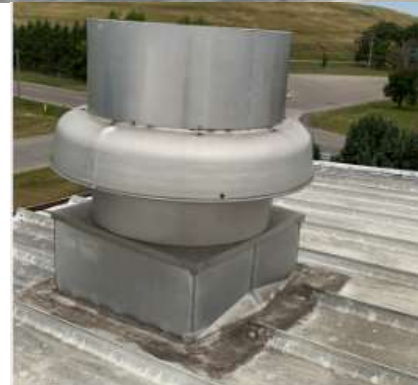
2. Material Transfer Station – Roof Safety

Many of the exhaust fans are within a couple of feet of the roof edge. If these units require future servicing, the installation of roof guards need to be installed as a safety measure for staff servicing the equipment.

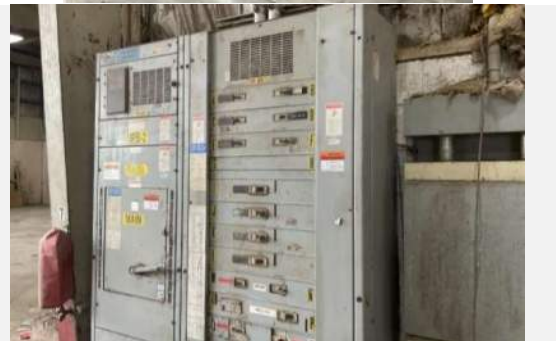
3. Material Transfer Station - Location of Ext. Electrical Assets

Although electrical assets appear to be functional, this electrical switchgear and adjacent electrical panelboards are located in the same area where vehicles are continuously dumping solid waste/garbage. These assets are exposed to this very dirty and unconditioned environment and should be in a separate enclosure to help prolong useful life.

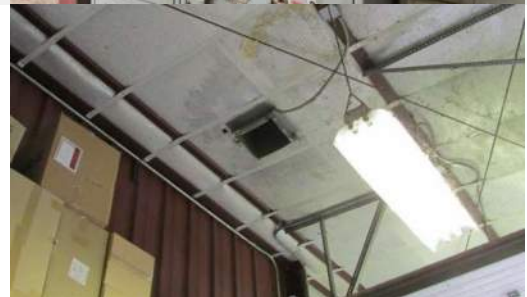
4. Snell Generator Building - Potential Roof Leak(s)

Although not observed during the on-site evaluation, Staff has indicated that water intrusion from the roof has occurred in a few different locations. Areas of stained insulation panels illustrate areas where water is potentially infiltrating from the roof.

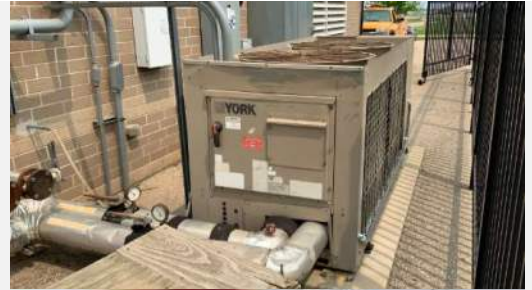
1. Air Traffic Control Tower – Undersized Chiller

Per conversations with Airport Staff, the existing chiller needs to be replaced with a larger unit that can serve the required heat loads of the Air Traffic Control Tower. Increased heat loads are likely due to solar gain from extensive glazing.

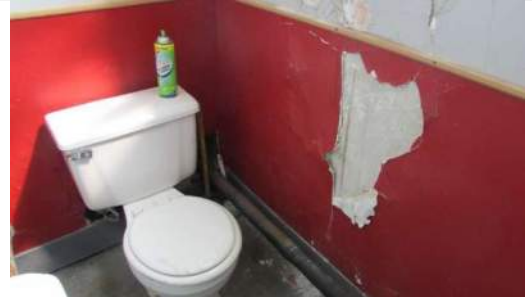
2. Hanger #7 Valley Aviation – Wall Damage

There are a variety of locations within the Valley Aviation Center where plaster deteriorated and has fallen off the walls.

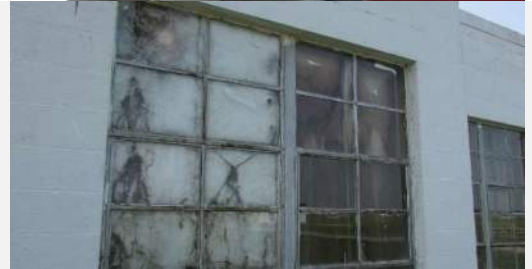
3 Hanger #7 Valley Aviation – Windows

Windows in the Valley Aviation facility appear to be original to the 1946 structure and have panes of broken glass with very corroded window frames.

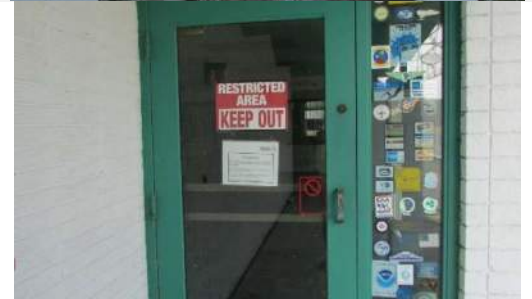
4. Basler Office #14 – Restricted Access

Airport Staff have recently restricted access to the Basler Office. This is likely due to water intrusion and the presence of mold.

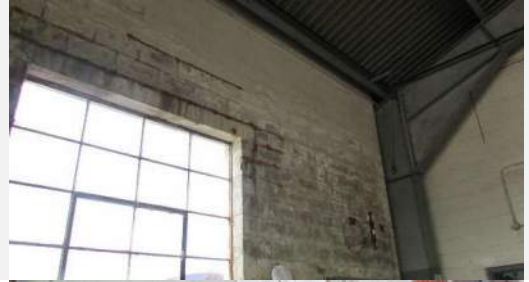
5. Hanger #13 Basler East – Wall Damage

The interior CMU walls in Hanger #13 Basler East have significant efflorescence which is an indicator of water intrusion.

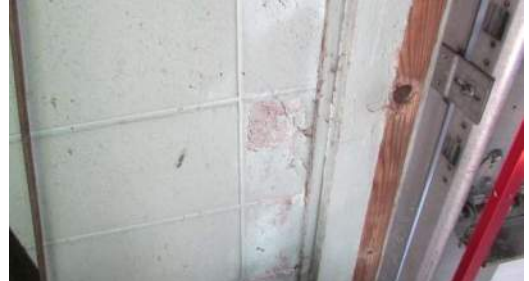
6. Wittman Fire Station #9 – Wall Damage

The interior CMU walls in Apparatus Bay have peeling paint and significant efflorescence which is an indicator of water intrusion. Additionally, some of the CMU's are beginning to physically deteriorate.

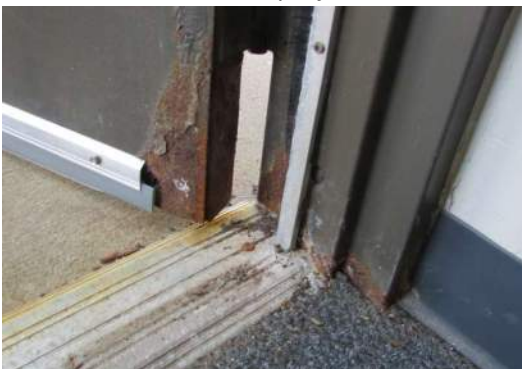
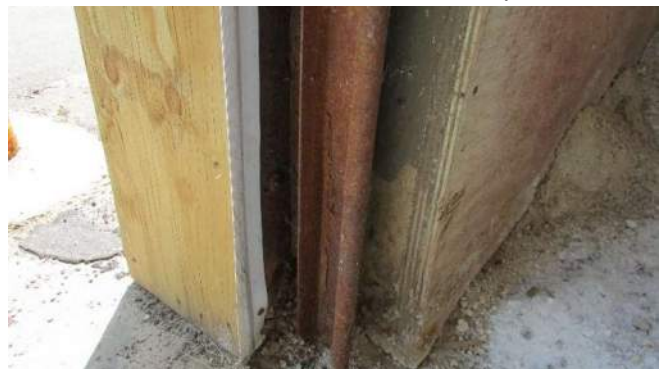
- Salt is used on sidewalks, walkways, and roadways, which, over multiple winter seasons, has caused deterioration of both overhead door tracks and pedestrian door frames. When feasible, consider the installation of stainless-steel door frames and alternatives to the standard metal overhead door tracks on future construction projects in locations where it is known that salt is used extensively.

Human Services Cntr- Neenah – Rusted Door & Frame HWY Dept – Winchester Salt Shed –Rusted Overhead Door Track

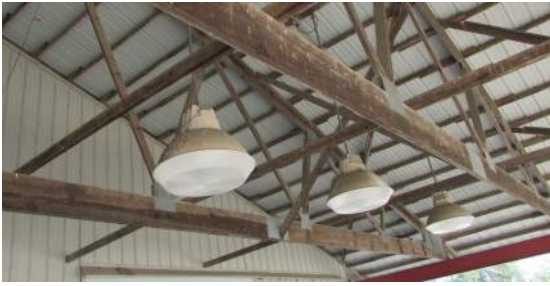
Expo Site – Barn E – HID Lighting Fixtures

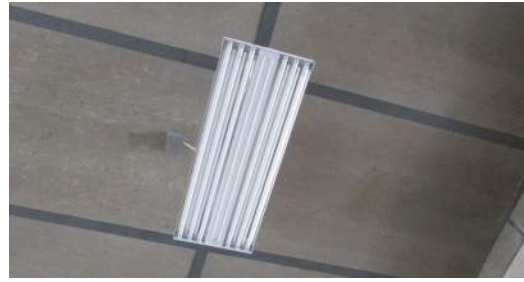
Wittman Field – Basler East Hanger – T8 Lamp Fixture

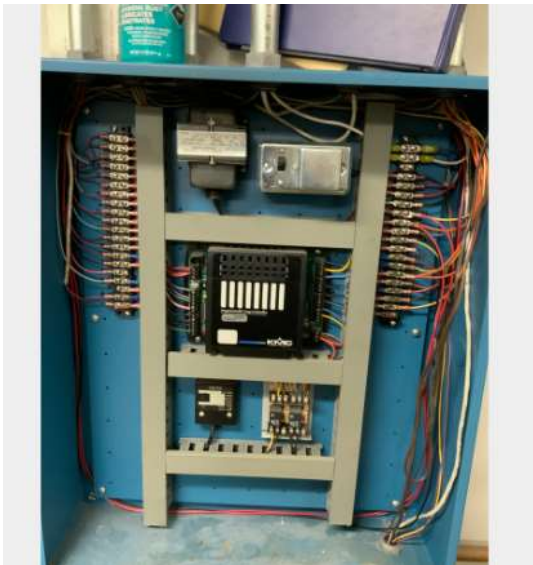
- Large facilities in the County utilize industry standard direct digital control (DDC) systems for controlling the heating, ventilation, air conditioning (HVAC) equipment. However, more antiquated temperature controls located at Orrin King (pneumatic controls), Wittman Field - Fire Station (pneumatic controls), Highway Maintenance - Main Facility (original 1995 digital controls), and the many stand-alone thermostats used in facilities throughout the County should be evaluated further to determine cost effectiveness of incorporating into the existing "head-end" DDC system for improved temperature control monitoring and energy efficiency practices.

HWY Dept – Main Office – Original 1995 Controls

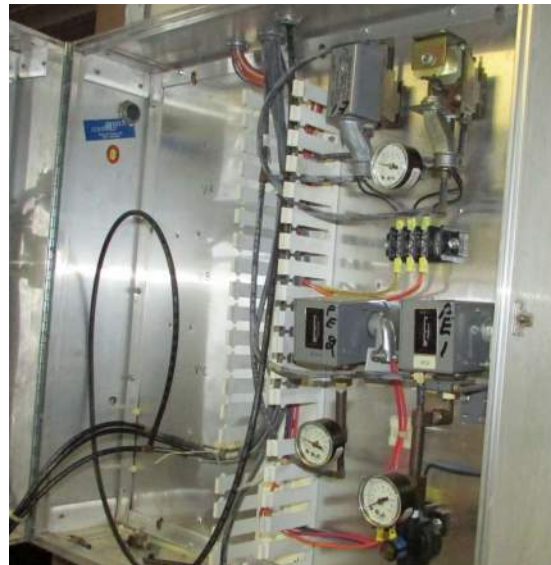
Human Services Center – Oshkosh – Pneumatic Panel

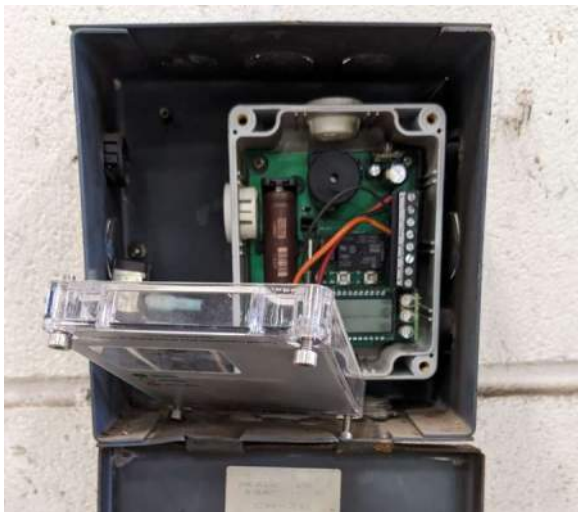
- The County owns and operates a variety of vehicle maintenance shops and storage garages. Although many of these areas are equipped with CO / NO₂ sensors to sequence ventilation systems necessary to purge spaces of residual diesel and gasoline combustion fumes, it was noted that many of these sensors and/or systems don't appear operational. In some cases, the CO/NO₂ sensors appear original and have exceeded their useful life and effectiveness to properly control ventilation systems. A more comprehensive evaluation should occur that focuses on this aspect of health and safety. Examples of facilities include (but are not limited to):

HWY Dept – Storage Garage – Broken CO/NO₂ Sensor

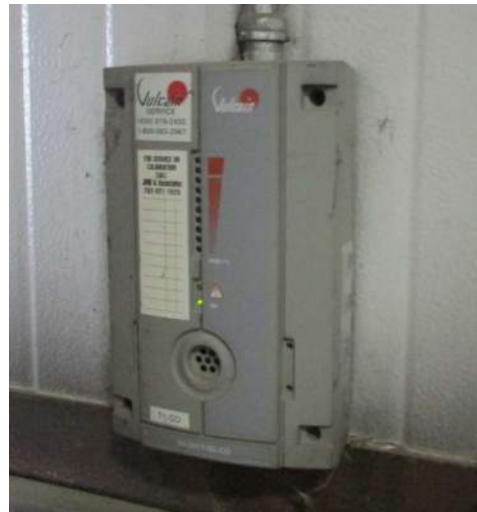
HWY Dept – Cold Storage -CO/NO₂ Sensor
